Portobello High Street, Edinburgh Remediation Strategy

Aldi Stores Ltd

Report Ref	Issue	Prepared by	Date	Reviewed by	Date
14517RS	1	N Watson	20.02.15	A Coverdale	20.02.15

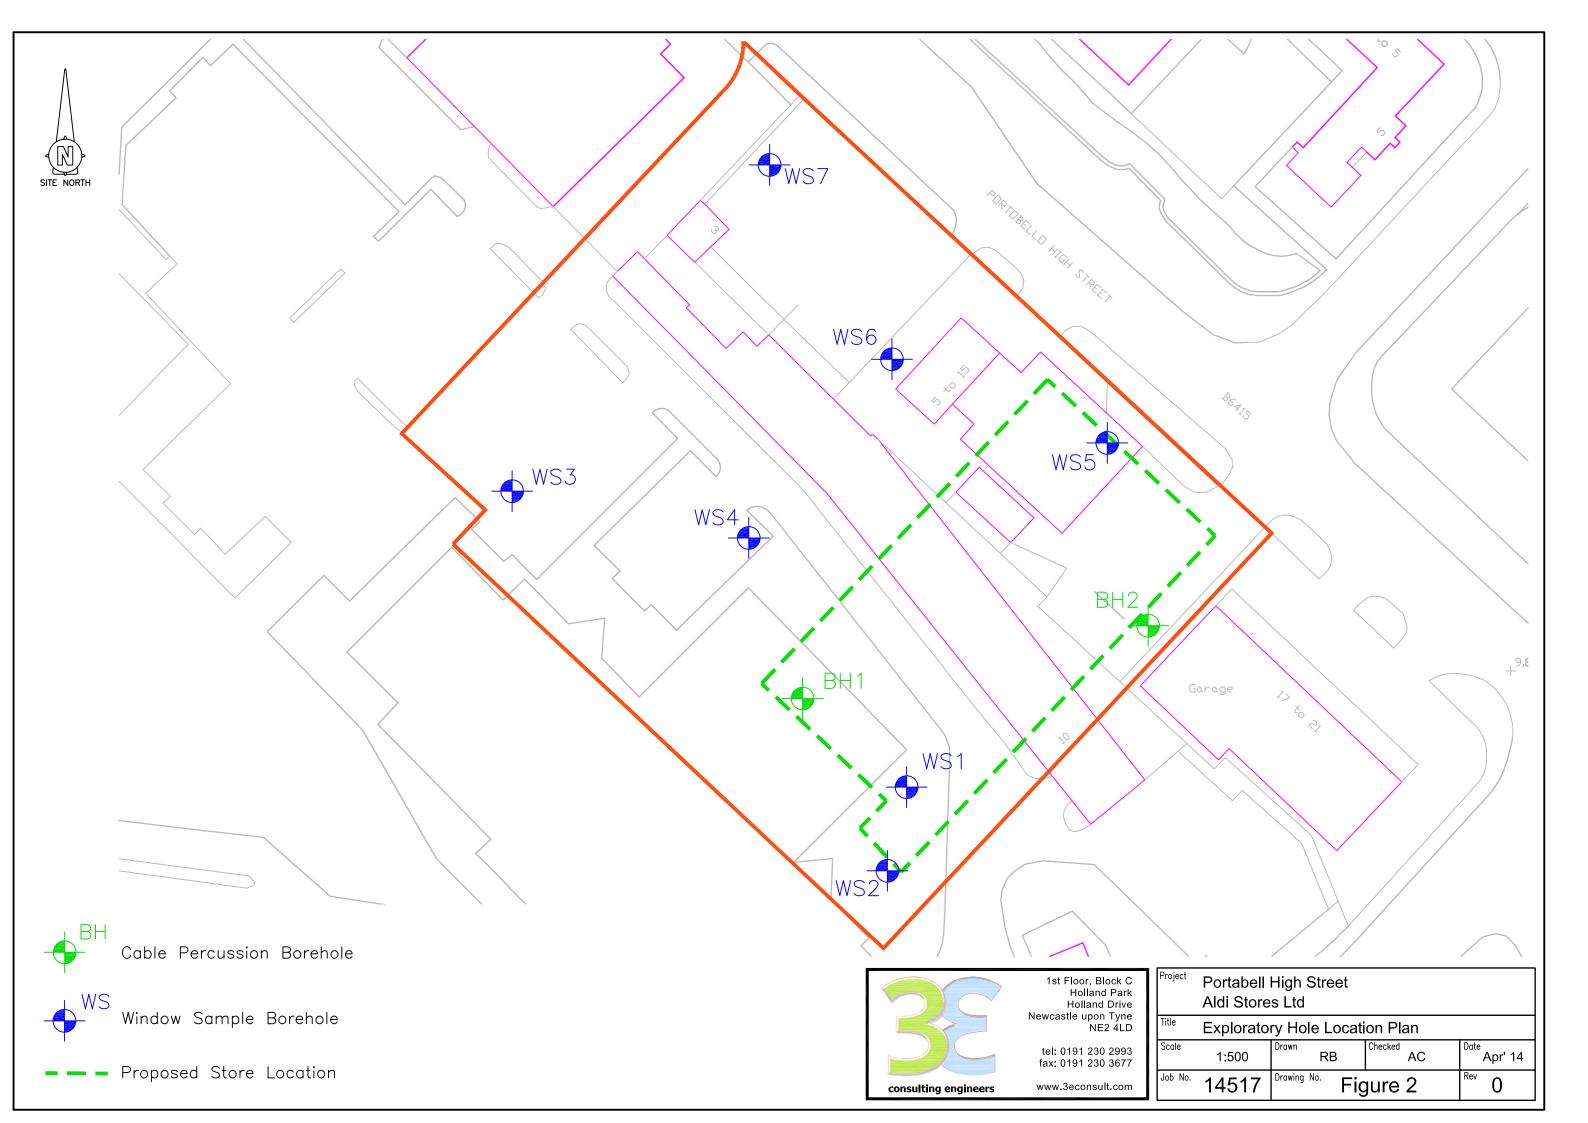
Figure 2 Exploratory Hole Location Plan

- 1.2 3e Consulting Engineers (3e) carried out Phase I and Phase II Geo-environmental Assessment Reports for this site during 2014 to assess the ground conditions and contamination levels, at locations as shown on the Exploratory Hole Location plan, included as **Figure 2**. As part of this report, reference has also been made to an additional Phase I Geo-environmental Assessment report completed by WSP Environmental Ltd (WSP), for this site and surrounding wider development area, during 2008 (Ref. 12151488).

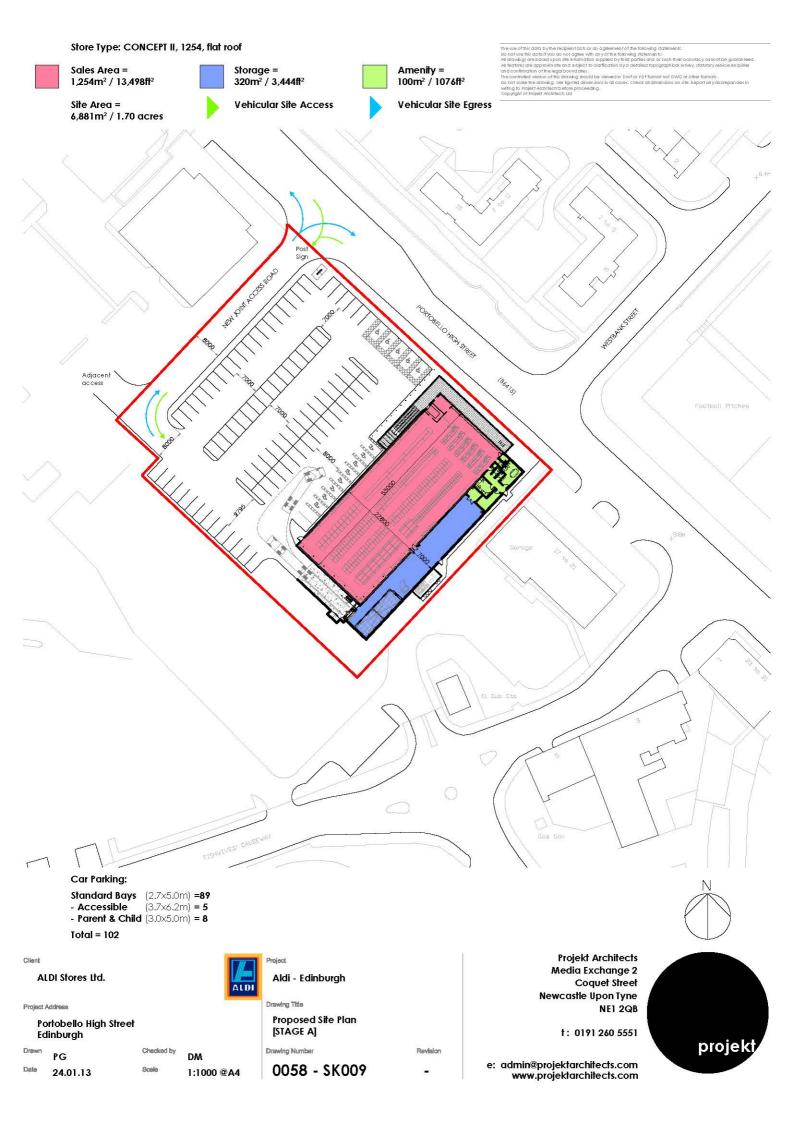
Appendix A

Proposed Development Plans

- 1.1 It is proposed to develop the site of a former fuel filling station, with areas of car parking, and an adjacent building for a commercial development, with the proposed site plan included in **Appendix A**. The site, centred on National Grid Reference 330130, 674220, is located on the north-eastern side of Edinburgh adjacent to Portabello High Street, around 250m from the coastline of the Firth of Forth. A site location plan is included as **Figure 1**.
