CLIENT -  
CITY OF EDINBURGH COUNCIL

PROJECT -  
PORTOBELLO BAPTIST CHURCH CLOCK

DRAWING -  
PROPOSED SECTION

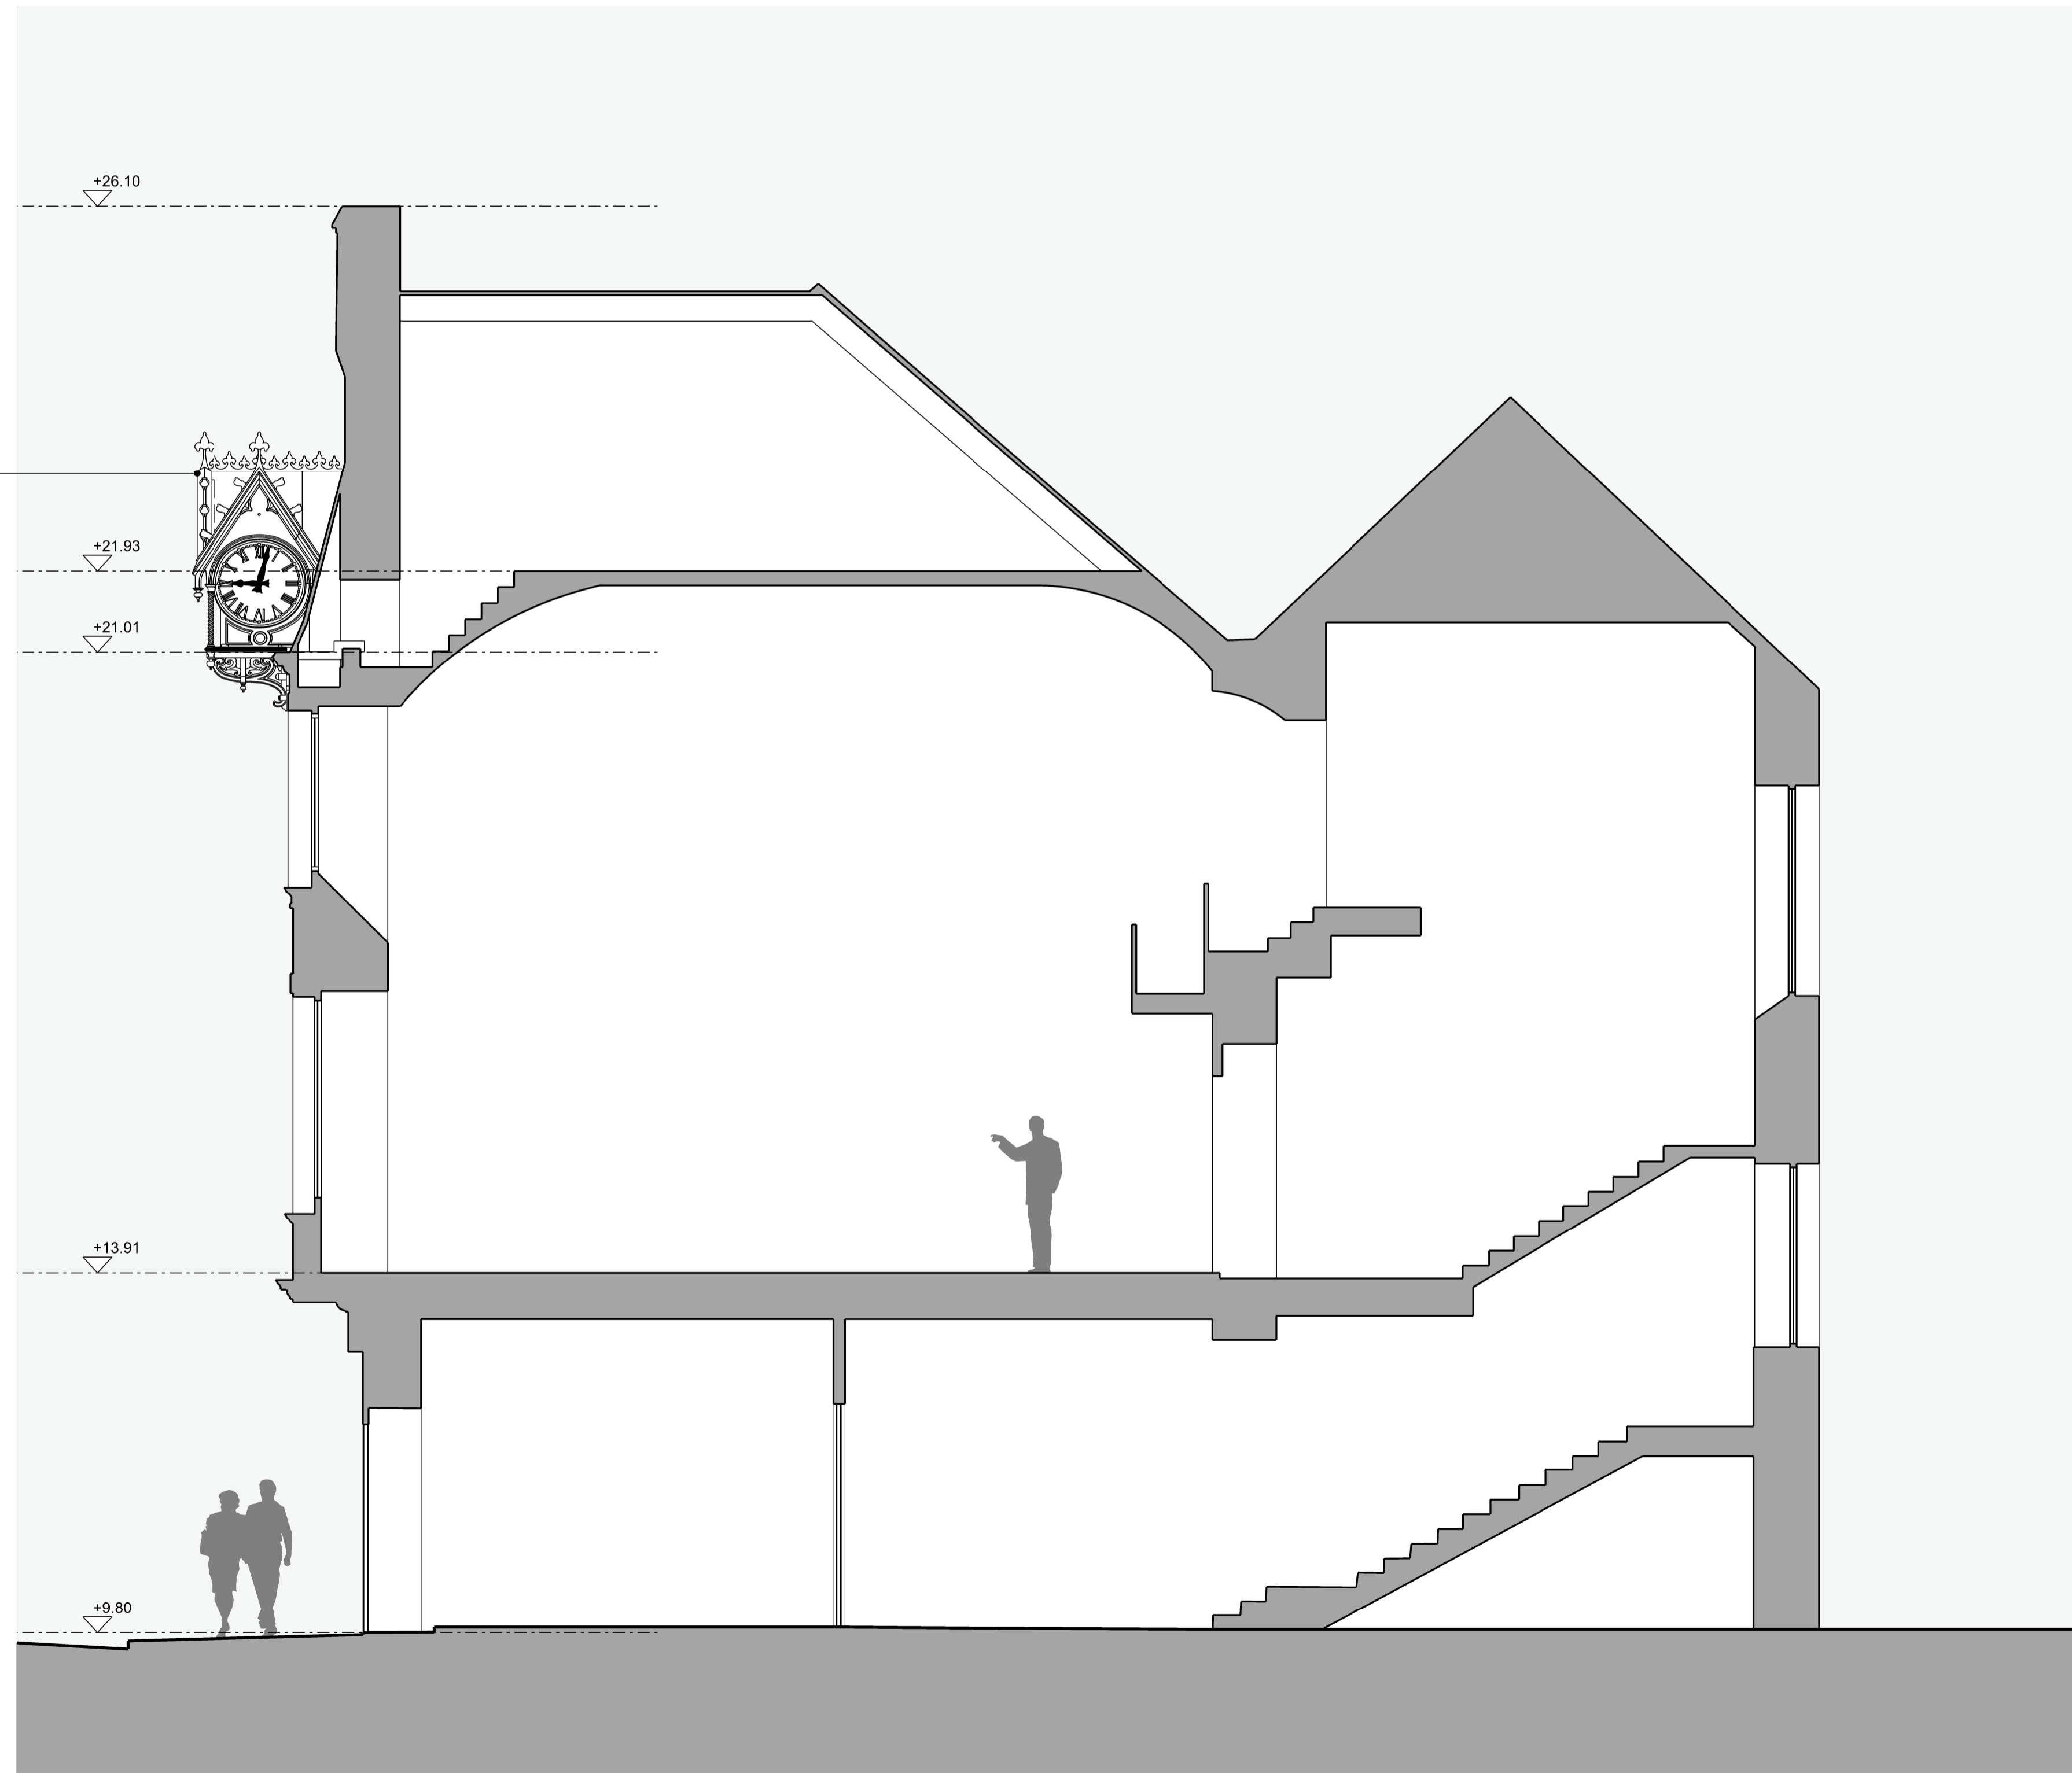
Section

Existing clock casing and mechanism fully refurbished and reinstated to original location.

Existing fixing beam in-situ for re-use.

Requires amendment to stone lintel above central window to allow clock brackets to slot through - note lintel previously replaced when clock was removed to repair bracket holes.

New roof formed to clock with copper sheet roof finish.
