CLIENT -
CITY OF EDINBURGH COUNCIL

PROJECT -
PORTOBELLO BAPTIST CHURCH CLOCK

DRAWING -
PROPOSED ELEVATION

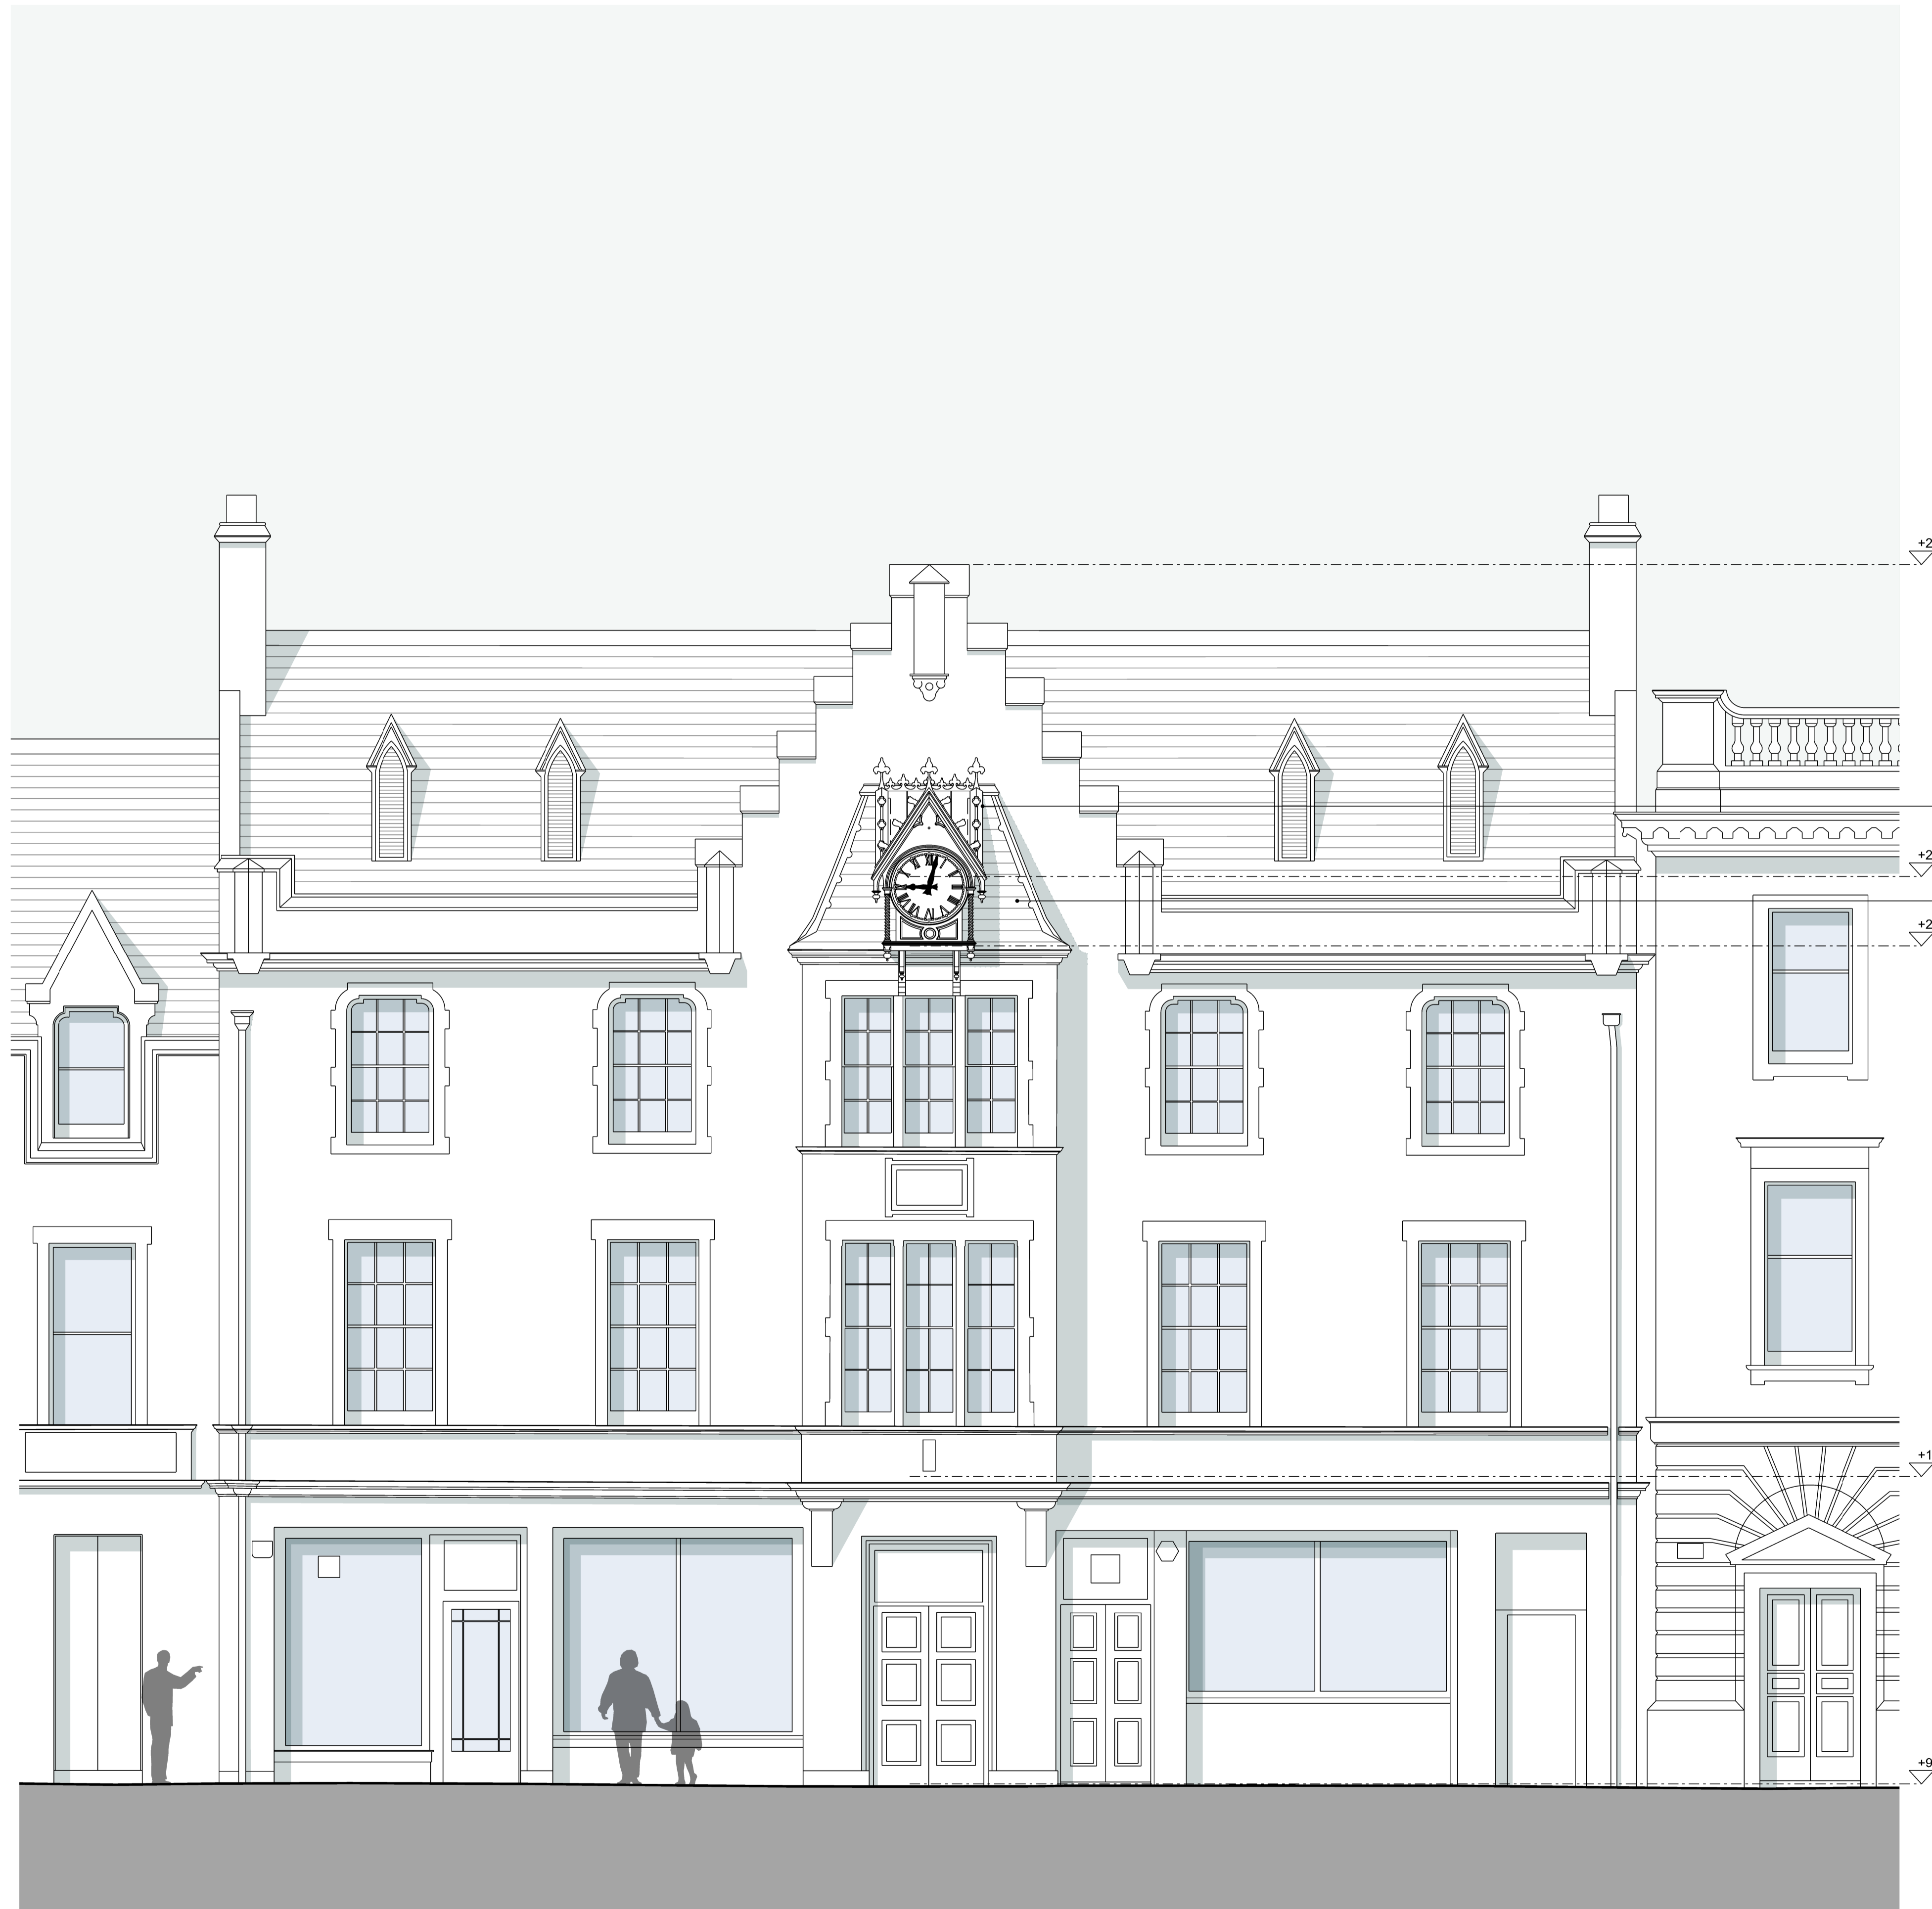
North Elevation

+26.10
Existing clock casing and mechanism fully refurbished and reinstated to original location.
Existing fixing beam in-situ for re-use.
Requires amendment to stone lintel above central window to allow clock brackets to slot through - note lintel previously replaced when clock was removed to repair bracket holes.
New roof formed to clock with copper sheet roof finish.

+21.93
Existing felt roof replaced with slate to match existing on main roof
